## **Investigation of Sustainable Design Strategy to Maximise Energy Efficiency: A Case Study of Silverbird Mall, Abuja and Ado Bayero Mall, Kano.**

**Abubakar Yusuf; Ahmad Abubakar; & Zakari Tijjani  
Abdullahi**

Department of Architecture, Faculty of Earth and Environmental Sciences, Kano University of Science and Technology, Wudil.

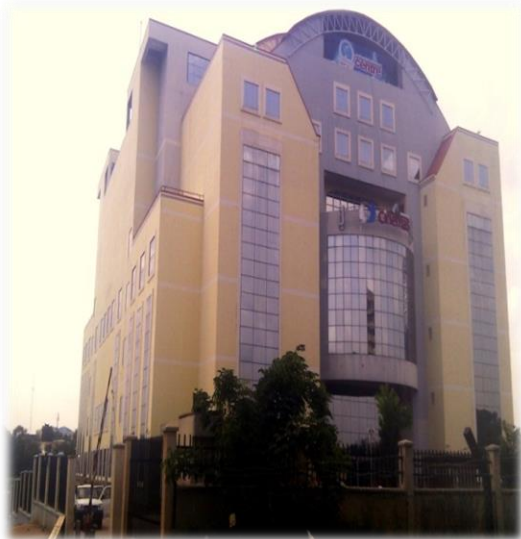
Figure 1: Building envelope of Sliver bird center  
Source: Author 2023

The exterior of the building consists of plastered masonry unit (CMU) painted with beige and grey exterior and different variety of colours for different spaces within the building. The masonry unit is highly suitable for the tropical climate of the region. However, the building is not insulated externally to prevent heat radiated from exterior from spreading the interior of the building, hence the need for heating, ventilation and cooling (HVAC) system achieves thermal comfort leading to high energy consumption in the shopping mall. The finishes on the exterior wall utilized light beige colour which doesn't contribute to the heat generated in the interior of the building.

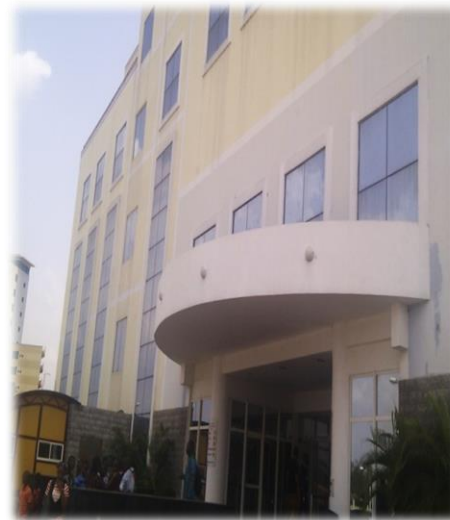
Figure 2: Exterior wall of the building with window openings  
Source: Author 2023

The use of reflective glass to help reflect light, the shape and direction of the building wasn't adequate enough. Efforts were made to have adequate lighting through the use of large windows which spans from one end to the other in the various functional spaces to allow adequate coverage of natural light in some spaces. Natural ventilation was also achieved through the use of large windows, some of which were openable. Inadequate interwoven landscape and impervious surfaces of the building is observed. This indicates that sustainable design strategies with respect to landscaping was not considered in the initial stage of the design of the mall. In addition, the implication of inadequate landscape is that, air flow from exterior of the building to the interior will not be diffused with enough soft landscape elements like trees and shrubs thus, making the interior of the building thermally inconvenient for users resulting to high energy consumption.

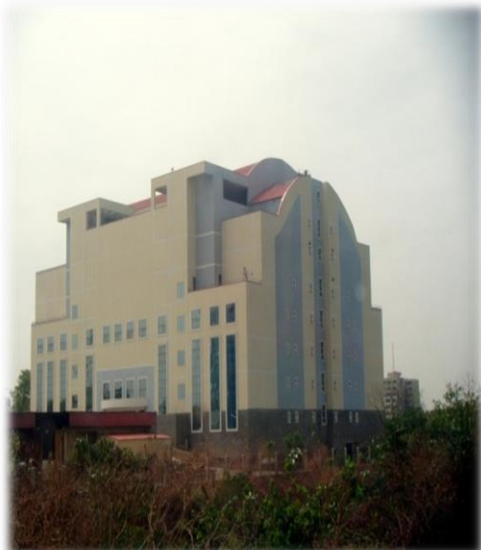
Figure 3: External wall painting of the mall  
Source: Author 2023

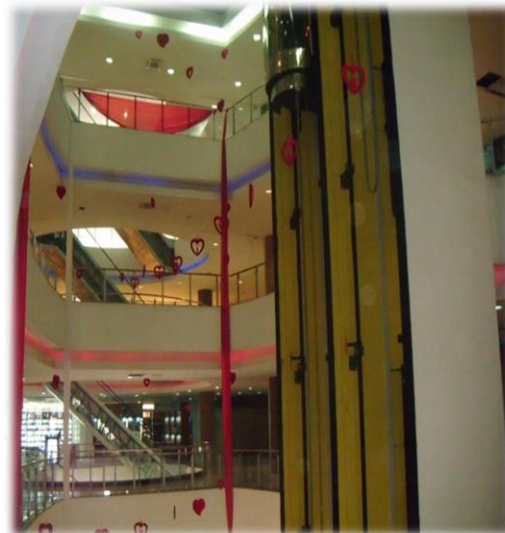
Figure 4: Interior blinds of Sliver bird center  
Source: Author 2023

The shopping center is well orientated to accommodate sunlight and airflow. This is maximized by the provision of openable windows on the perimeter walls of the mall. There are eave projections in some areas especially along the restaurant extension, but they don't shade the windows, Venetian blinds do shade from within. No horizontal or vertical shading device was utilized in the mall. The existing energy source is municipal power from PHCN which is not reliable so they depend mainly on generators. These generators use about 10000 liters (average) of diesel per month resulting in increase in energy consumption. The mall was constructed using concrete and glazing (reflective glasses) for walls, marble tiles for floor, white patterned suspended ceiling and plaster of Paris (POP) ceiling.

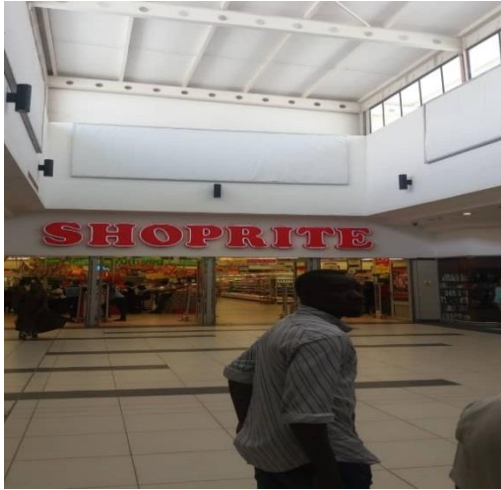
Figure 5: Glazed opening in Ado Bayero Mall  
Source: Author 2023

With regards to natural lighting, the use of extensive large windows made of single clear glass causing heat gain was used in both cases. Wall to window ratio is adequate in sliver bird mall but very inadequate in Ado Bayero mall. Adequate natural ventilation was provided for in Sliver bird mall but was inadequate in Ado Bayero mall.

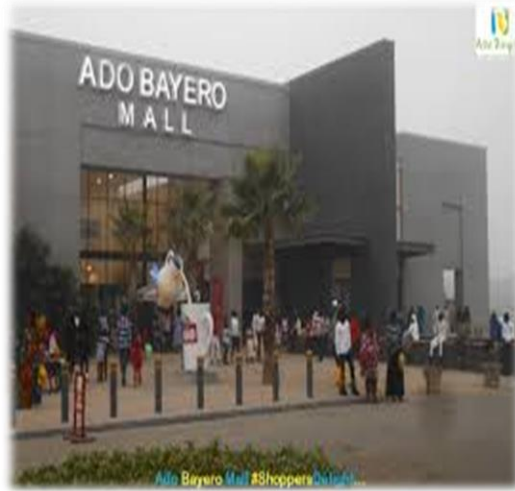
Figure 6: Exterior of Ado Bayero Mall  
Source: Author 2023

This section analyzes the sustainable design strategies present on the mall. The exterior of the building is painted with light colors. The concrete masonry unit is highly suitable for the tropical climate of the region as shown in Table 3 above. However, the building is not insulated externally to prevent heat radiated from exterior from spreading the interior of the building, hence the need for heating, ventilation and cooling (HVAC) system achieves thermal comfort resulting in an increase of energy consumption in the mall. The modes of admission of daylight into the building are Electrical means and some windows, however, most spaces still made use of artificial lighting.

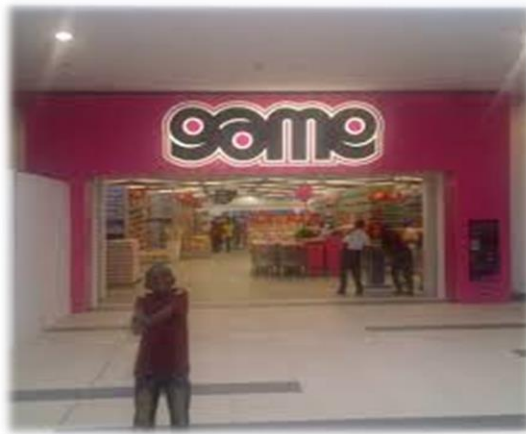
Figure 7: Recessed internal wall view. Ado Bayero Mall  
Source: Author 2023

Very adequate provision of interior blinds was spot on both cases studied. Ado Bayero Mall utilized more of recessed walls compare to sliver bird mall. The use of fixed overhangs at some point was spotted in Sliver bird mall while absent in Ado Bayero Mall. Both shopping mall was not properly shaded with the use of plants.

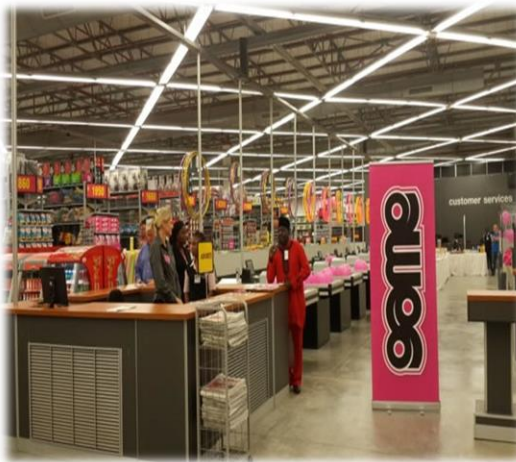
Figure 8: Artificial lighting in Ado Bayero Mall  
Source: Author 2023
